DEFECTIVENESS OF EXTERNAL AND INTERNAL SURFACES OF THE MAIN OIL AND GAS PIPELINES AFTER LONG-TERM OPERATION

Abstract. Damage by pitting corrosion of the surface areas of the local oil and gas pipelines was identified and numerically analysed in this paper. Having used the methods of optical and scanning electron microscopy, the basic laws of structural and mechanical degradation were established. Based on the data of fractographic control, the shape of defects and substantiated morphological characteristics were examined. It was established that certain informative signs of the defects correspond to certain stages of operation. Having used methods of fractodiagnostics, the main reasons for the performance defects of main oil and gas pipelines were established, and the mechanisms of degradation as well as fracture of the materials they are made from were described. According to the findings, the cause of the decrease in the reliability of the main oil and gas pipeline networks is general and localised corrosion as well as technological defects in the pipeline metal. These studies are essential for the establishment of the complex of mechanical and corrosion-mechanical properties, p

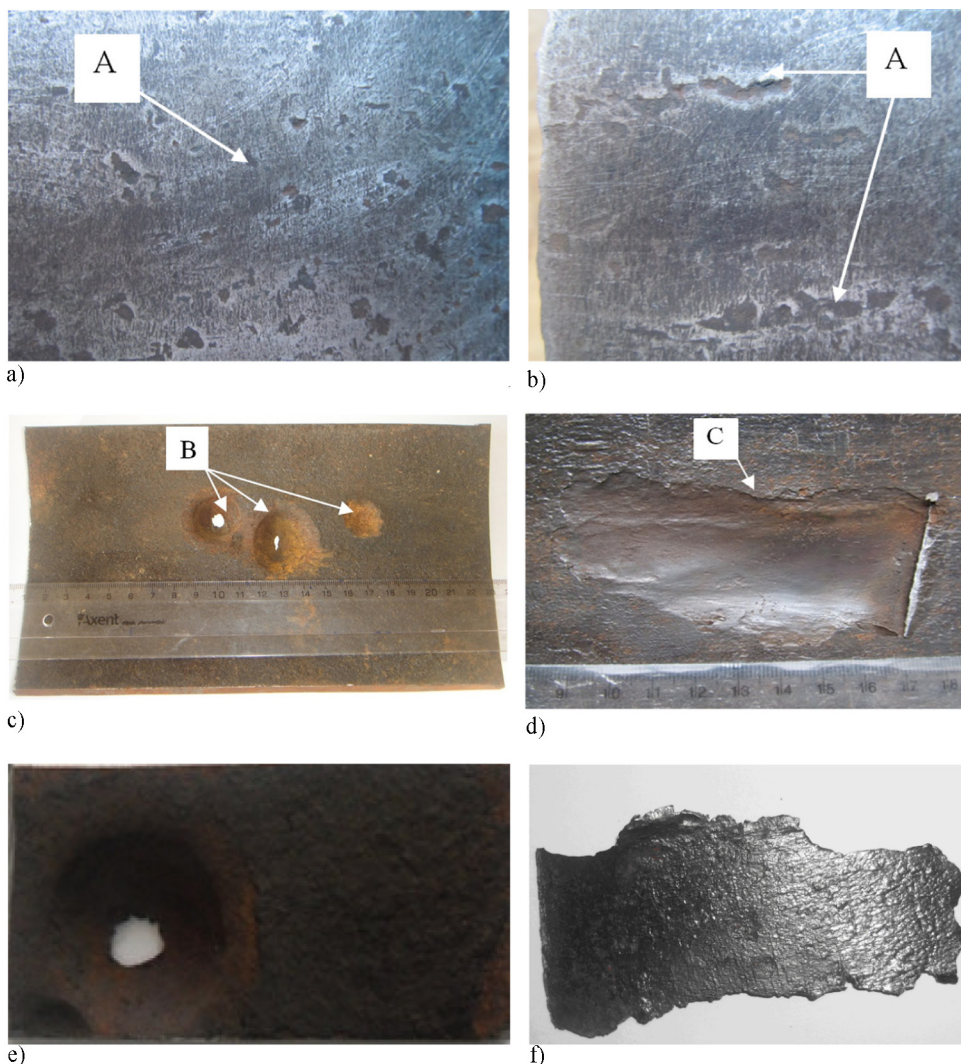
Black inclusions in the form of corrosion pits were found on the surface of the gas pipeline fragment (Fig. 2a, b). It should be noted that some characteristic sections, within which the corrosion damage of the metal occurred, could be seen on the metal surface.

Fig. 2. Investigated in-service defects of oil and gas pipelines: a, b – pitting; d, f – film peeling; c, e – megalospheric corrosion pits; A, B, C – defects are indicated by arrows

Using the methods of the optical or scanning electron microscopy, it was established that the fracture surface is covered with a dense network of deep, large-sized (200–500 μm) pits, which were the result of the corrosion effect during operation.

The shape of individual corrosion pits is uneven, which can be explained by the non-uniform fibrous structure and a high anisotropy of the pipe steel properties, which increases due to degradation, causing non-uniform localisation of the corrosion process (Maruschak *et al.* 2014a; Aleksandrov *et al.* 2011).

Defects in the form of through holes in the pipeline wall were investigated (Fig. 2c, e). Fragments with through holes were cut from the damaged section to determine the reason for their formation. The results of determining the chemical composition of the gas pipeline fragment are presented in Table 3.

According to the *optical macroanalysis* of the internal and external surfaces of the pipe in the initial state and after deseaming, holes have a semispherical shape. The semi-sphere diameter on the internal surface of the pipe is 22 mm. A hole with the diameter of 6 mm appeared on the external wall, the metal thickness in the vicinity of the hole is less than 0.5 mm (Fig. 4a). The internal surface of the defect is covered with a thick layer of oxides. The oxides have sections of local bulging, in which a layer of corrosion separated easily from the lower corrosion layer. This testifies to the fact that corrosion developed gradually, in a stepwise manner within this section. There are traces of the uniform corrosion and

A tongue-like defect was found on the pipe surface, which is joined with the base metal of the pipe on one side. These are the so-called films – metallurgical defects caused by violations of the pipe production technology. Films of the steelmaking origin are located randomly along the surface of the metal sheet and have a significant thickness of local delamination (above 1.0 mm), and the size up to 35 mm, which is similar to the case under investigation.

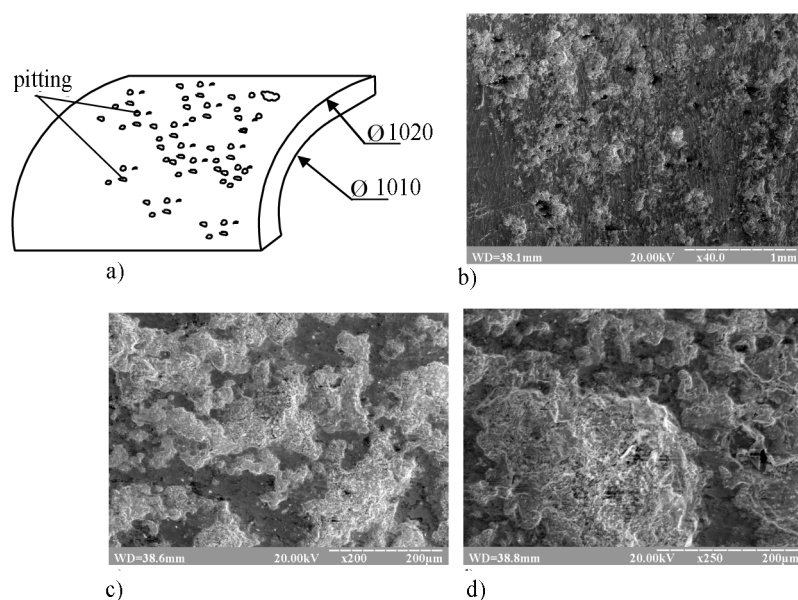
The presence of the pitting corrosion (Fig. 3a) intensifies degradation processes due to:

- the formation of the atomic hydrogen on the pipe surface in case of penetration of the ground water into the pipe surface (Nykyforchyn *et al.* 2009b);
- metal decarbonisation resulting from blockage of carbon atoms by the diffusion hydrogen atoms;
- metal hydrogenation and accumulation in dislocations, structural defects and micropores;
- metal embrittlement.

Thus, for the investigated sections of the main pipelines, the danger it is not in multiple pitting (Figs 3b–d) but the activation of the structural and mechanical degradation caused by them.

Fig. 3. Scheme of multiple pitting location on the pipe surface (a); local (b) and coalesced pitting (c, d)

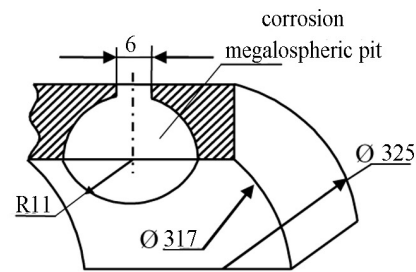
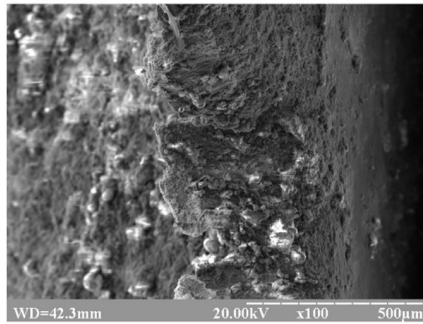
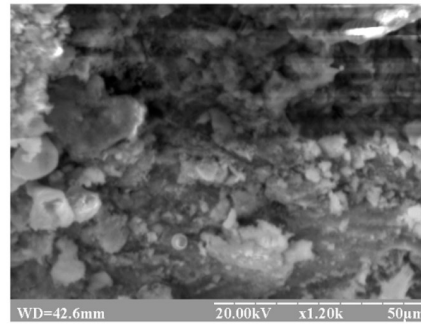
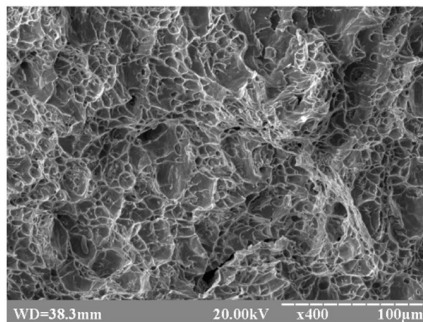
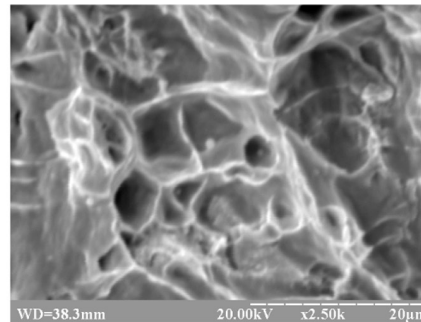
Fig. 4. Scheme (a) and the surface of the corrosion of a semispherical hole (b, c) and the surface of static failure of the pipe material (d, e)

The use of the *optical microanalysis* for the geometry analysis of the corrosion defect bottom testifies to the absence of crack-like defects. The view of the through hole and the general condition of templates testify to an insignificant intensity of corrosion processes on the gas pipeline wall. Based on the results of the damage analysis on the pipeline surface, a conclusion can be made that the through hole with the maximum diameter on the internal wall and the minimum diameter on the external wall is a corrosion pit, which propagated from the inside (Fig. 4a). The shape and locality of the defect allow presuming the presence of a technological defect of the pipe within this area (most probably a film or flanging).

According to literature (Chernov *et al.* 2002a, 2002b), the sources of corrosion defects of this type are deviations from the process mode during casting and rolling of the pipe metal. This preconditions the chemical and mechanical non-uniformity of the near-surface lay-

The analysis of the hole surface morphology allowed establishing that the material has a surface fragmented with corrosion, on which flanges covered with the corrosion film are formed (Fig. 4b, c).

It should be noted that the mechanism of steel failure depends on many factors (strength, structural degradation, the presence of concentrators). Failure of the material near the hole occurred in a ductile manner. A dimple relief testifies to the presence of non-metallic inclusions. We can presume that the dimples with the diameter above 10 µm are caused by the presence of the non-metallic inclusions of oxides and sulfides, whereas the pits of smaller size are connected with the intrasubgranular mechanism of failure or the formation of pores on dispersed particles (Fig. 4d, e). The attainment of the critical volume of pores caused a beginning of microplastic deformation, coalescence of pores and fast failure.

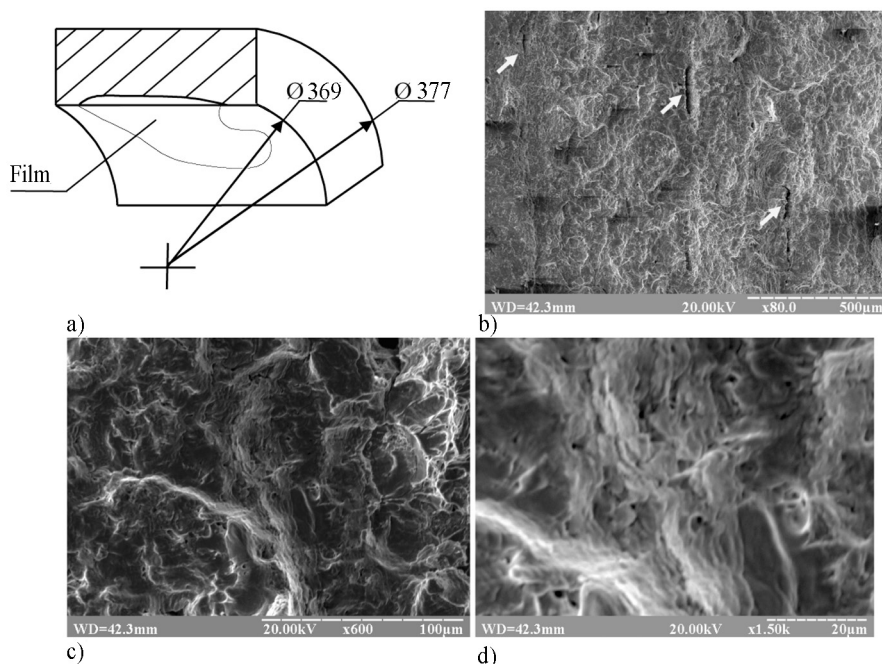
The use of the complex technique for investigating the defects of “film” type (Fig. 5a) and the analysis of pipe production technology allows identifying the reasons for the formation of this type of damage on the walls of the main oil pipeline systems. The external view of the defect of “film”-type represents thin, tongue-like delamination of metal plates from the pipe surface of the oil pipeline (Fig. 5a). The delamination has a shiny dark colour.

The defect was found to have a structural gradient along the depth of fracture (Fig. 5b). In particular, longitudinal delamination of different sizes was noticeable very well. The defects were oriented along the direction of rolling and looked like delamination caused by the effect of hydrogen on the metal (Szkłarska-Śmiałowska,

Lunarska 1981; Alamilla et al. 2013). This also indicates a significant role of hydrogen in degradation, which is evolved due to the corrosion interaction between the steel and the external medium and which diffuses partly into the metal. Hydrogen can influence the deformation of metal, causing the development of damage, including the nucleation and propagation of submicrocracks. The hydrogen cracking results from the accumulation of atomic hydrogen under significant tensile stresses in the pipeline wall (Szkłarska-Śmiałowska, Lunarska 1981; Alamilla et al. 2013; Azevedo 2007; Cao et al. 2010).

The structure of the fracture is formed by the lateral shear mechanism (Fig. 5c, d). In general, the surface has a “smoothed-out” look, and a decreased roughness, which testifies to a low energy efficiency of the material fracture.

Fig. 5. Film fracture surface (a) and micromechanisms of its fracture (b, c) (hydrogen delamination is indicated by arrows)
