CONTEMPORARY TWO-STOREY CHURCHES – ACOUSTIC INVESTIGATIONS

Abstract. The paper discusses the idea of two-storey churches, with insight into socio-political conditions which influenced their construction. The analysis of the issue was carried out on the basis of investigations in five two-storey churches in Poznań. The churches under investigation were: Visitation of Blessed Virgin Mary Church, Christ the King Church, Our Lady of Częstochowa Church, St. Lawrence Church, and Christ the Redeemer Church. In total, ten interiors were examined. The churches were erected in the late 70s and early 80s of the 20th century. The acoustic conditions were analyzed in terms of cubature, the shape of the interior and finishes. The upper and lower churches were compared within one building; the investigation also involved comparing the churches against each other. Moreover, functionality of the buildings was analyzed, which included aspects of acoustic as well as architectural functionality.

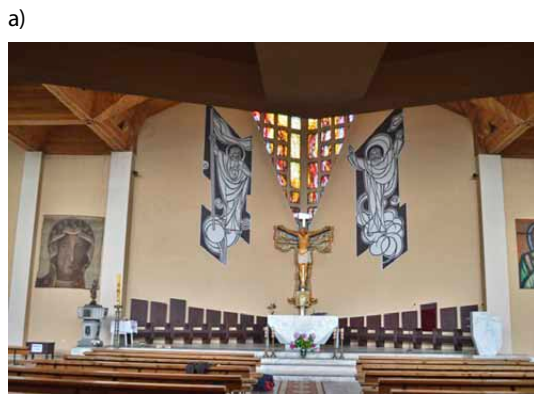
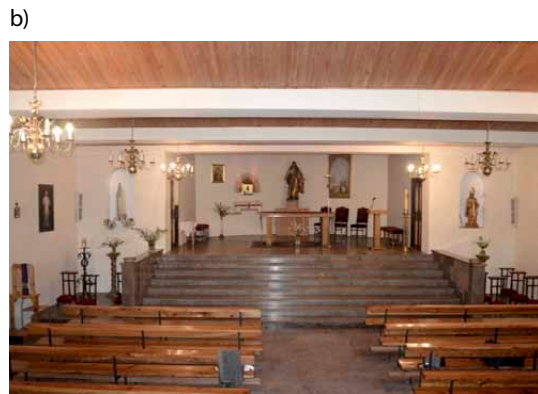
Fig. 1. Christ the King: a – upper church, b – lower church (photo by author)

Christ the King church (Figs 1a and 1b)

1a. Upper church – cubature 4600 m³
1b. Lower church – cubature 315 m³

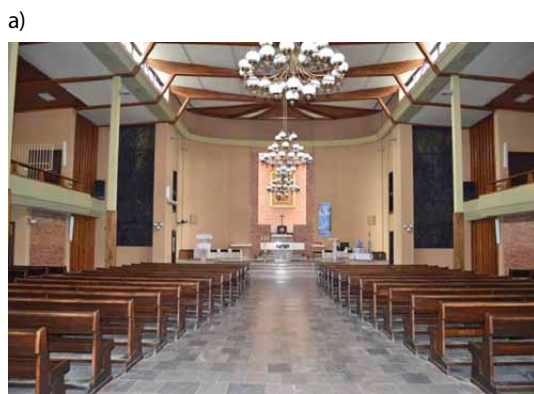
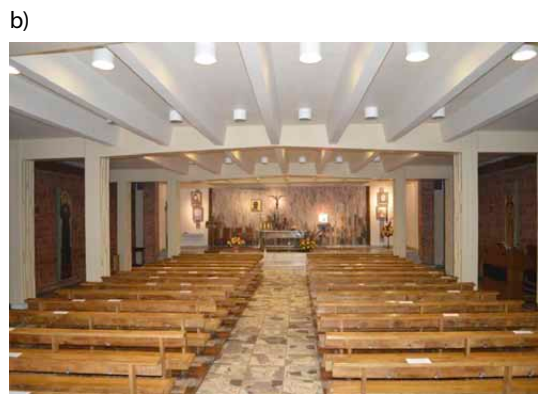
Fig. 2. Christ the Redeemer Church: a – upper church, b – lower church (photo by author)

Christ the Redeemer Church (Figs 2a and 2b)

2a. Upper church – cubature 6700 m³
2b. Lower church – cubature 2100 m³

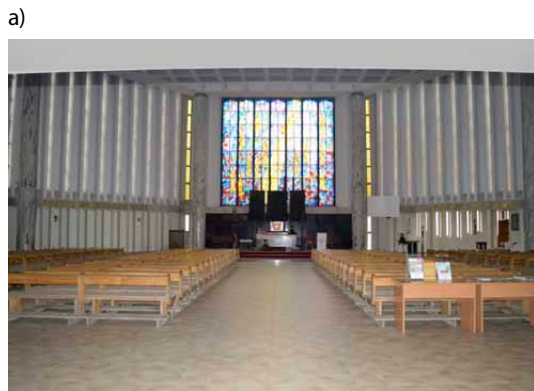
Fig. 4. St. Lawrence Church: a – upper church, b – lower church (photo by author)

The investigations showed that upper churches i.e. St. Lawrence Church (4a) and Visitation of Blessed Virgin Mary Church (5a) are particularly problematic. The shape of the church (4a) is a regular octagon. The floor is covered with marble, which is a solid material and the absorption coefficient is close to zero. Most of the interior is made of reinforced concrete, which has low acoustic absorption properties. In the wall behind the altar there is a vast stained glass window. The remaining walls have glazings in the form of narrow strips. The reinforced concrete coffered ceiling is massive and solid. Both the walls and the ceiling are textured, which promotes sound diffusion in the interior. However, the applied materials and the vast space result in considerably exceeded reverberation time amounting to about 6 s, while the recommended value should not exceed 3 s. Our Lady of Częstochowa Church (3a) is similar to the church (4a) in terms of the

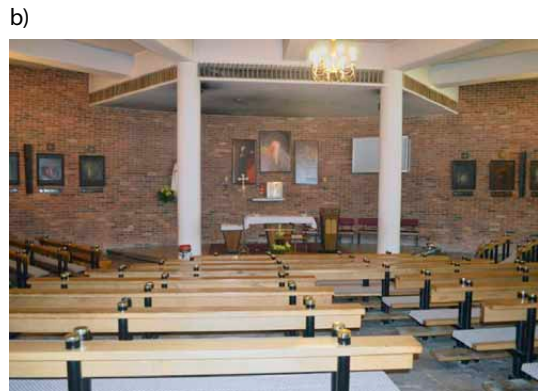
Fig. 3. Our Lady of Częstochowa Church: a – upper church, b – lower church (photo by author)

Our Lady of Częstochowa Church (Figs 3a and 3b)

3a. Upper church – cubature 7300 m³
3b. Lower church – cubature 3340 m³

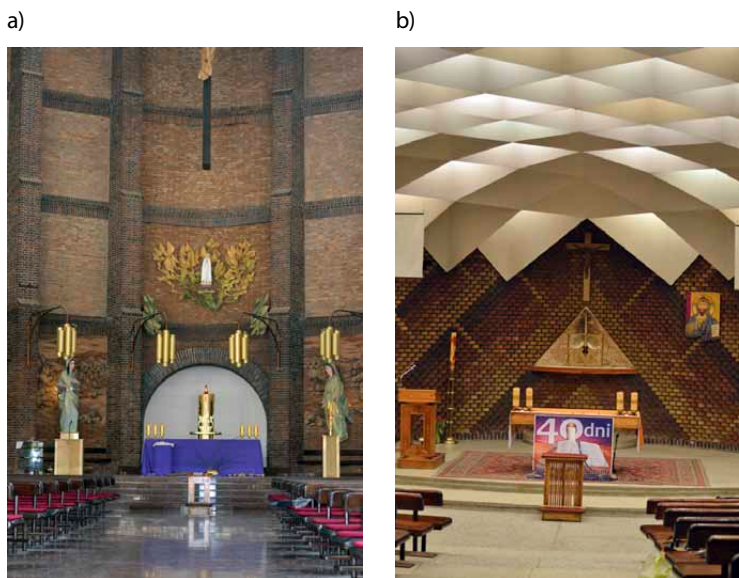
Fig. 5. Visitation of Blessed Virgin Mary Church: a – upper church, b – lower church (photo by author)

The church (5a) is considerably bigger from the other churches. The roof has a steel load-bearing structure. The surface of the ceiling is finished with gypsum lime plaster. The ceiling is concave; its area exceeds the area of the plan view of the church. The walls are made of brick. Brick pilasters are evenly distributed on the wall of the presbytery and the side walls. There are glazings inside, especially on the rear wall. The applied pilasters and zigzag shape of the ceiling affect sound diffusion in the interior. In terms of its cubature, the church belongs to the category of the biggest churches (Wróblewska, Kulowski 2007). Such churches often have a high-class organ, and their interiors are often used for concerts. Currently, the discussed church does not have a concert organ. The reverberation time is big and amounts to about 7 s.

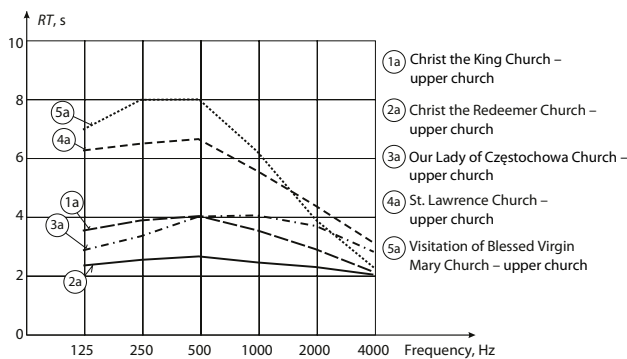
Table 2 shows the comparison of reverberation time RT and centre time T_s . In addition, reverberation time is shown in a frequency function, separately for upper churches (Fig. 7) and separately for lower churches (Fig. 8).

Fig. 7. Frequency characteristics of averaged reverberation time in the upper churches (created by the author)

Lower churches have smaller cubatures, the result of which is that reverberation time meets the recommendations or is slightly exceeded. Church (5b) is an exception as its cubature is equivalent to a middle-size church. For upper churches, reverberation time fits in with the recommended values only in the case of church 2a. It is caused by the shape and construction of the ceiling, which increases sound absorption. Churches (5a) and (4a) are the most problematic as reverberation time and other parameters considerably exceed recommended values. Results of the investigations confirm subjective perception of excessive reverberation in these churches. Their interiors have such high levels of reverberation noise that the reception of Holy Mass is disturbed and speech is unintelligible. In these cases, acoustic treatment would be necessary.

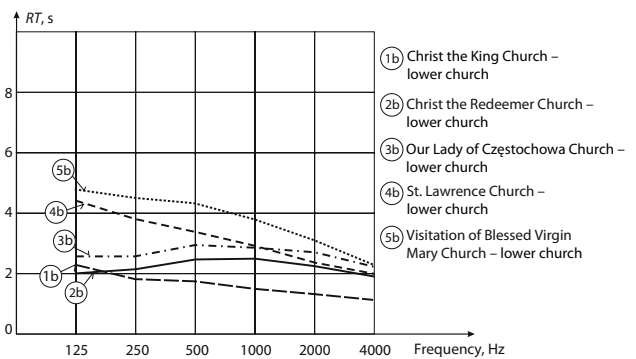
Fig. 8. Frequency characteristics of averaged reverberation time in the lower churches (created by the author)
