INVESTIGATION OF DEFORMATION PROCESSES IN CHANNELS OF REGULATED STREAMS

Raimundas Baublys

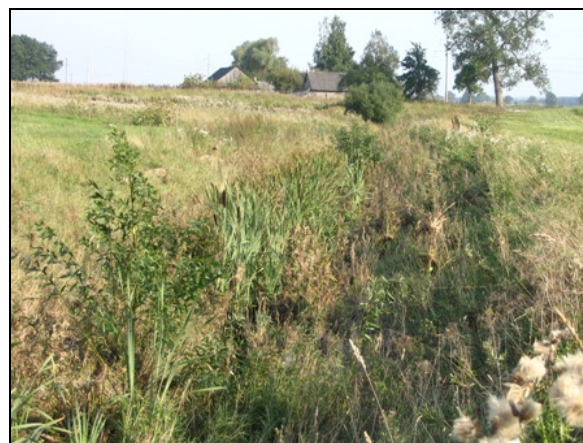
Fig 5a shows the intensity of grass vegetation cover in the channel of the regulated stream Viemuonia. After the accumulation of sediment on the streambed, high moisture-tolerant plants started growing (calamus, cat-tails). When there are plants in the channel, water flow velocity and hydraulic conductivity of the channel decrease,

Fig 5. Intensity of grass vegetation cover and meanders formation in the channels of the regulated Viemuonia and Šventupė streams: a) regulated Viemuonia stream, b) regulated Šventupė stream

The photos provided depict the state of streams, showing the meandering of the streambed and their overgrowth with grass vegetation (Fig 5).

which creates perfect conditions for channel silting. In this particular case the channel bed is overgrown with thick aquatic vegetation and thus stable water is retained in the channel. This stretch of the channel does not perform its initial role as a water discharge pipe of a drainage system. Fig 5b shows the peculiarities of meander formation in the channel bed of the regulated stream Šventupė. Considering the data collected from Agricultural Department of the Municipality of Kaunas district, during the last 5–8 years no maintenance and repair works were performed in the catchment area of the stream Jiesia. In non-maintained (not mown) slopes perfect conditions occur for rapid development of high grass vegetation (nettles, thistles) that spread over the entire stream slopes and choke other plants [7]. The examples discussed clearly show that deformations developed in non-maintained streams enhance the designed changes of regulated streams.

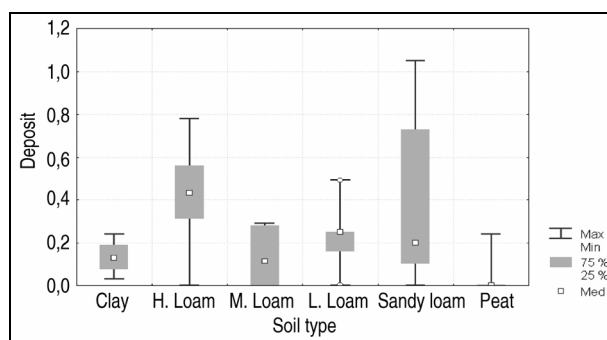
The thickness of sediment layers accumulated in regulated streams was also measured during the study. Connection between the depth of a sediment layer and the type of soil prevailing in the territory was determined. The study data are presented in Fig 8.

Fig 8. Dependence of deposit layer on soil type

Fig 8 presents summarized study data and depicts the cases of sediment accumulation and deformation occurrence under the conditions of different types of soils. The results presented in the chart show their spread, i.e. showing minimum, maximum values and densest areas of values (50 %). As it is seen from Fig 3, when sandy-loam soils are prevailing, the thickness of the layer of slid soil and accumulated sediment is changing within a wide range (0–1,05 m), and mostly (50 %) the layer mentioned varies from 0,1 to 0,73 m. When heavy loam soils are prevailing, the range of an accumulated sediment layer formation is 0–0,8 m, however, mostly (50 %) the formed layer is 0,3–0,55-m thick. Thus it can be stated that sandy loam soils are less stable, therefore, here the most significant deformations occur.
